# **Debris/Ice/TPS Assessment and Integrated Photographic Analysis of Shuttle Mission STS-94**

*Process Engineering/Mechanical System Division/ET-SRB Branch,  
Kennedy Space Center, Florida*

**DEBRIS/ICE/TPS ASSESSMENT  
AND  
INTEGRATED PHOTOGRAPHIC ANALYSIS  
OF  
SHUTTLE MISSION STS-94**

**1 July 1997**

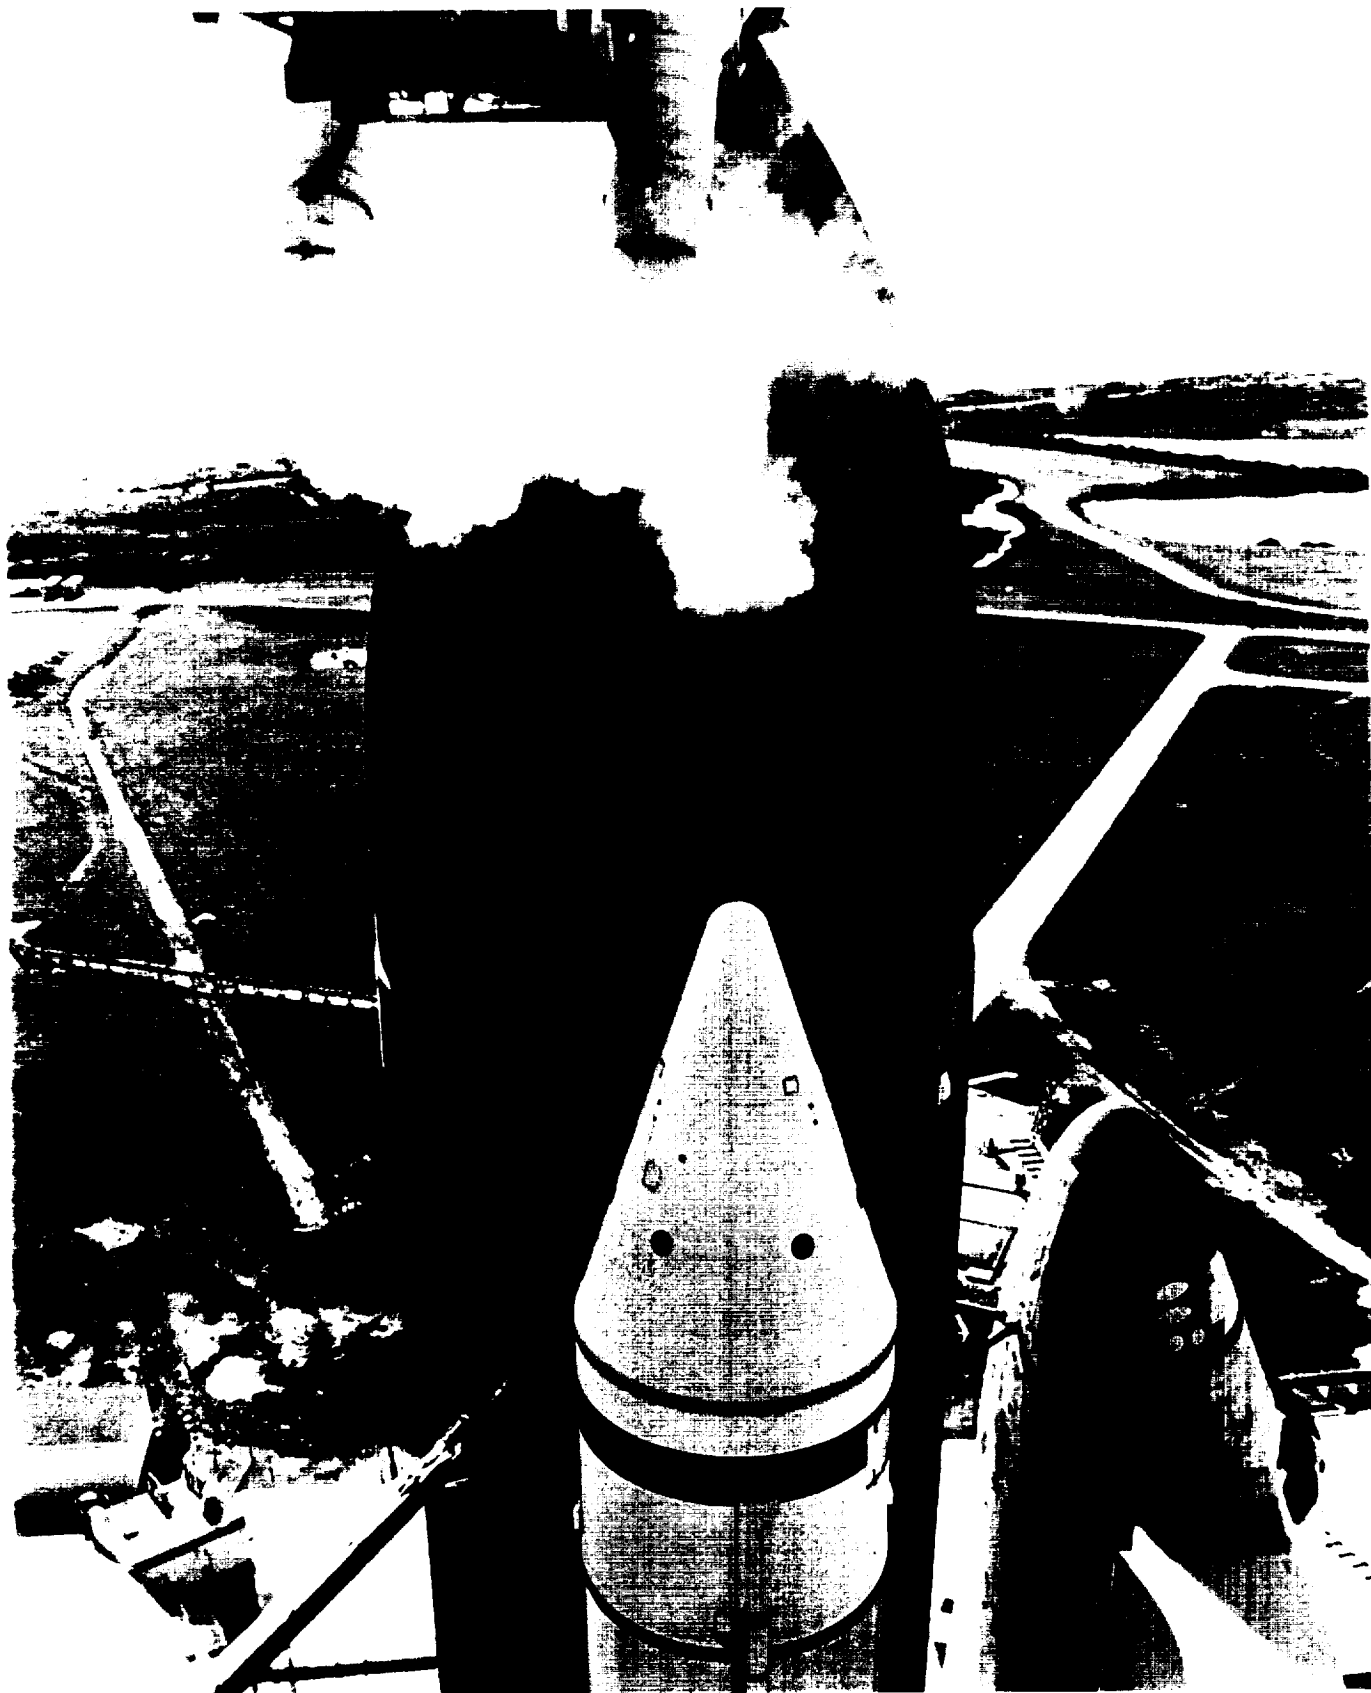
**Photo 3: LO2 Tank and Intertank After Cryoload**

The Final Inspection Team observed light condensate, but no ice or frost accumulations, on the LO2 tank acreage. TPS surface temperatures averaged 70 degrees F.

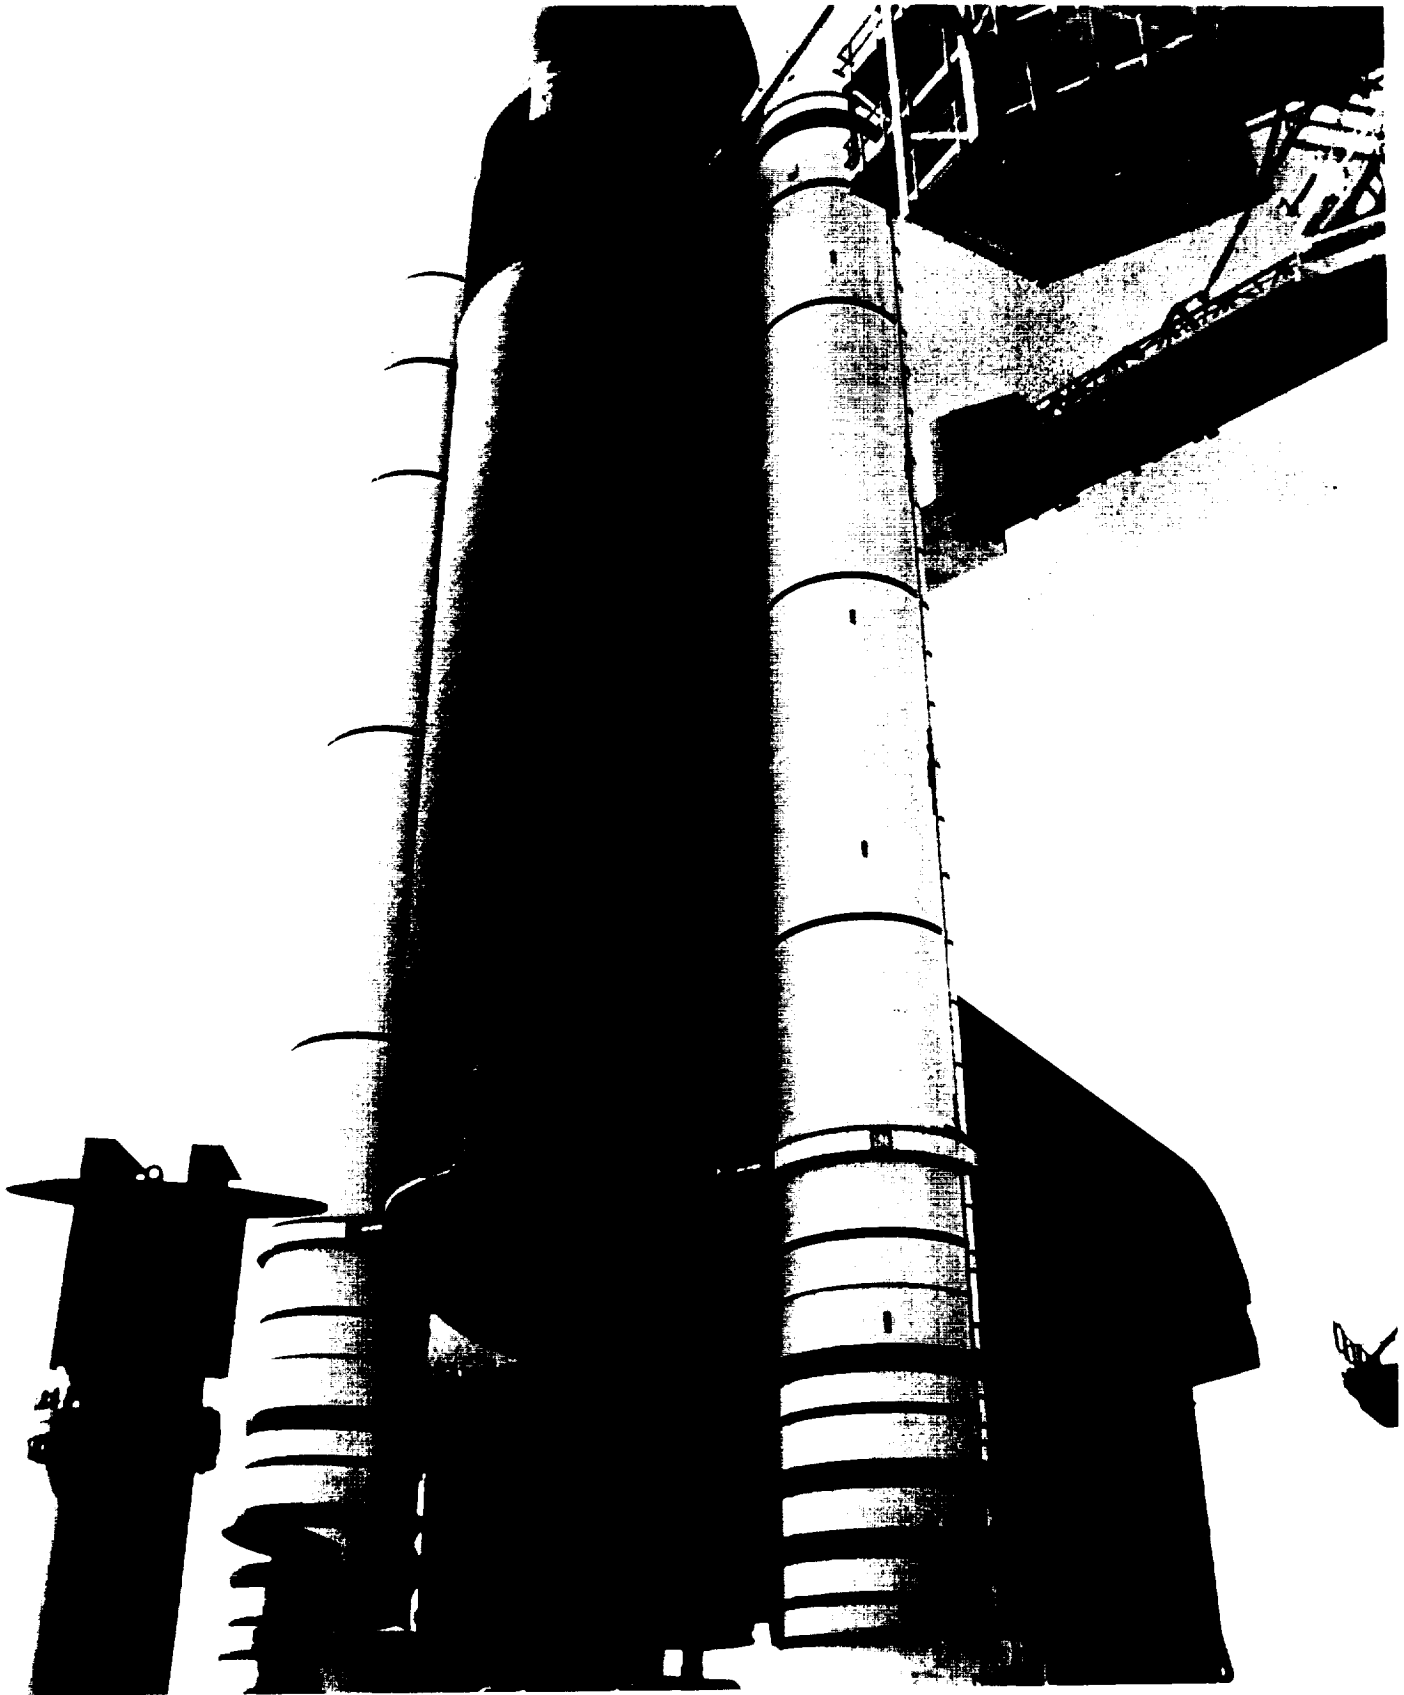
**Photo 5: ET LH2 Tank Acreege**

The Final Inspection Team observed light condensate, but no ice or frost accumulations, on the LH2 tank acreege. TPS surface temperatures averaged 68 degrees F.

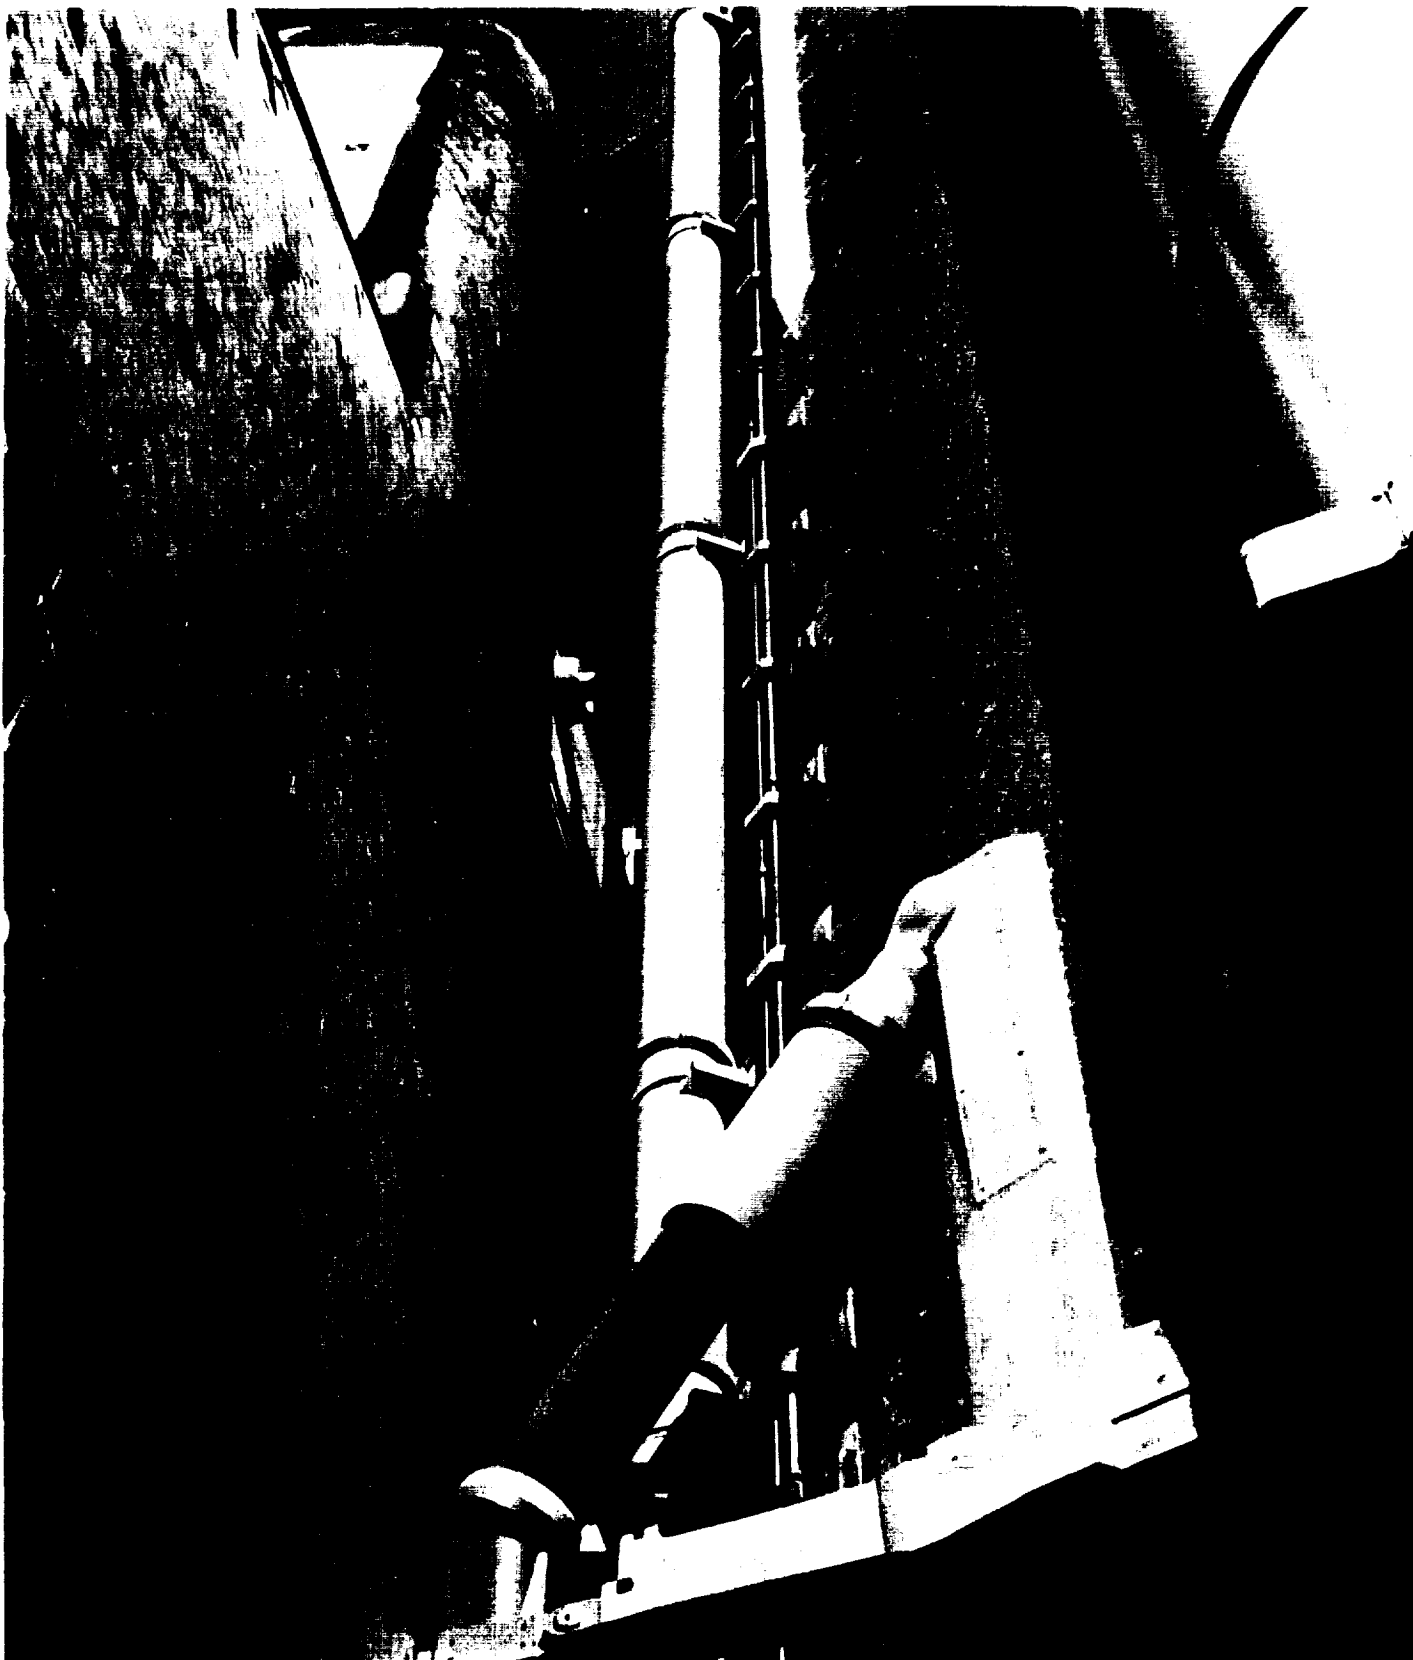
**Photo 7: LH2 Feedline and +Z Side Repairs**

The LH2 feedline bellows were wet with condensate. All TPS repairs on the +Z side of the LH2 tank were intact and in nominal condition.

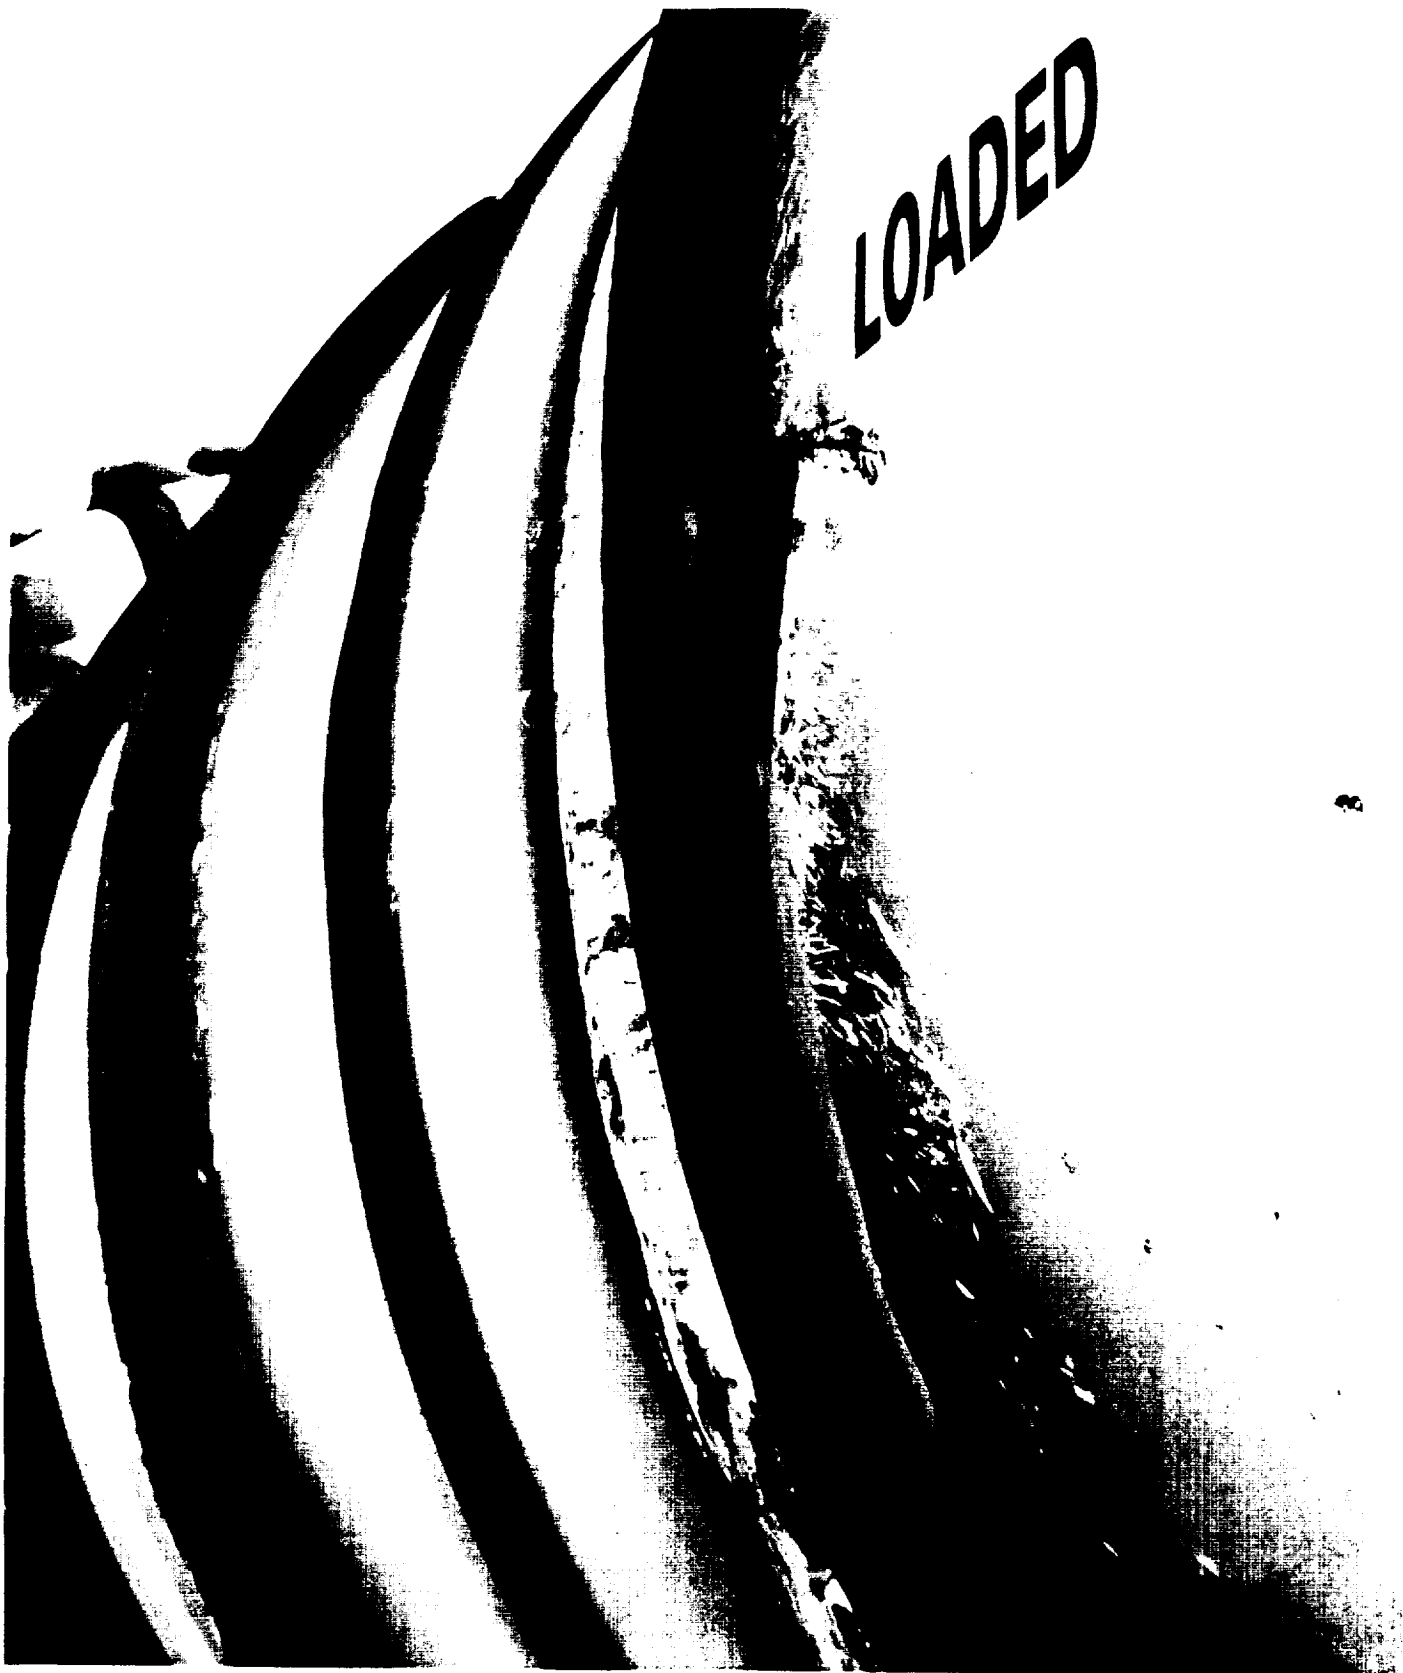
**Photo 20: LH SRB Stiffener Ring Damage**

The lefthand SRB forward stiffener ring had separated from the aft booster from approximately 200 to 290 degrees. Damage was most likely caused by splashdown.

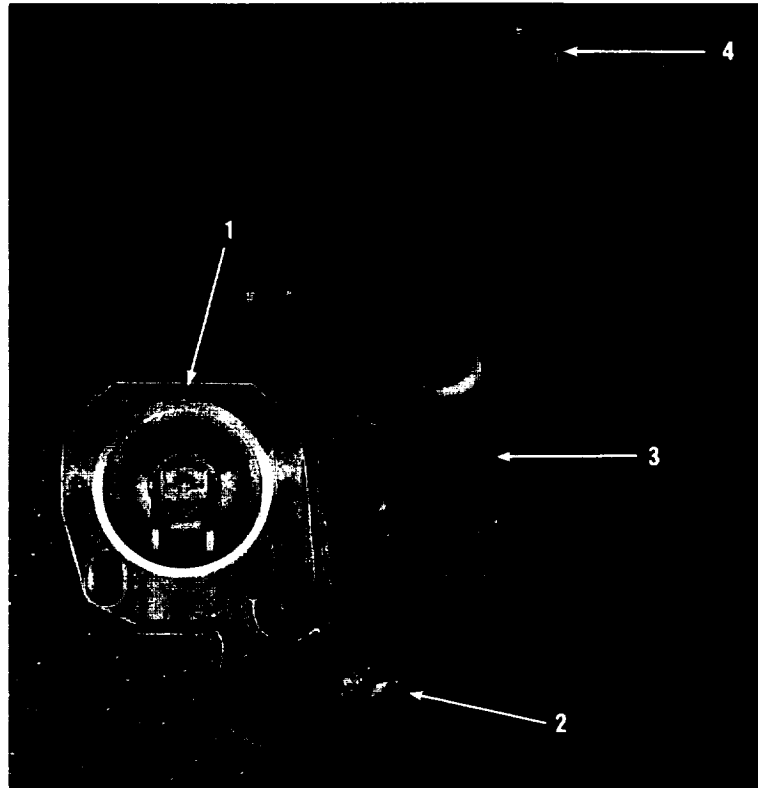
Figure 2.5.1 (A) ET/Orbiter LO2 Umbilical

One of the five lightning contact strips (12 o'clock position) appeared to be missing from the ET/Orbiter LO2 umbilical interface plate (1). KSC reported that STS-94 (ET-86) was the first vehicle to use the new "wire-mesh" electrical contact plates (lightning contact strips) on the LO2 ET/Orbiter umbilical. This new material is similar in form to umbilical foam and can give the appearance that a contact plate is missing. KSC confirmed that all five of the LO2 umbilical contact plates were intact and properly attached.

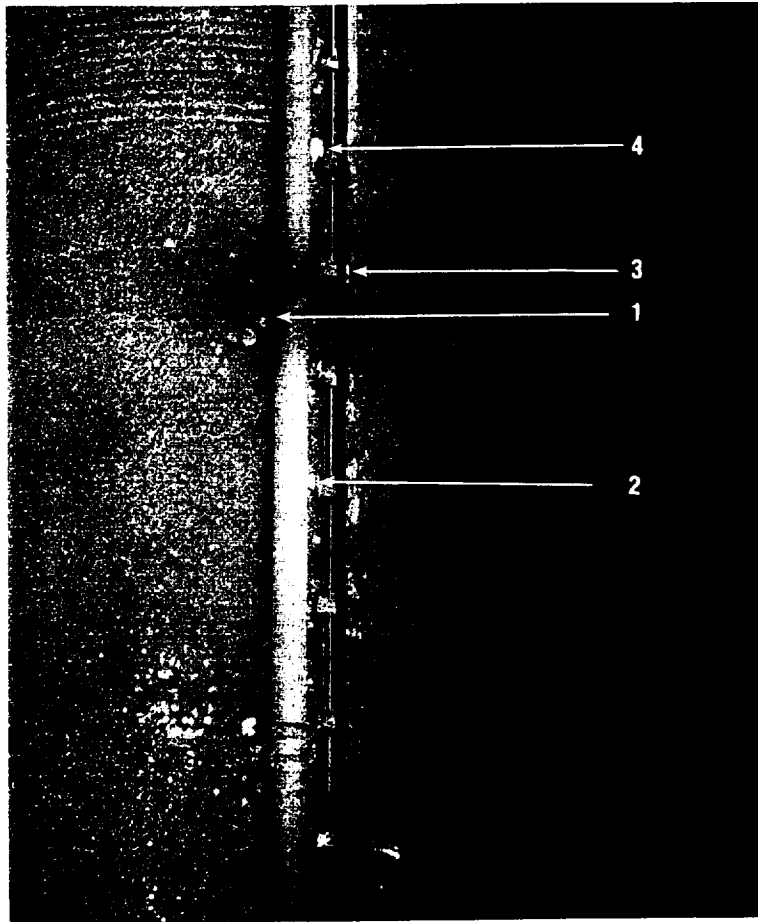
Figure 2.5.1 (B) LH2 Tank Divots

A shallow white mark (divot) approximately four inches in diameter was seen to the left of the LO2 feedline on the LH2 tank TPS at approximately station XT-1623 (1). Several divots were seen near the LH2 tank pressurization line and the LO2 feedline support brackets: a white mark (divot), approximately six inches in size, is visible between the LO2 feedline and the electric cable tray forward of the +Y thrust strut at approximate station XT 1722 (2), a 14-inch long divot was noted outboard (+Y) of the electric cable tray ramp at approximate station 1593 (3), and a 16-inch long divot was visible between the LO2 feedline and the pressurization line at approximate station XT 1528 (4).
